Manhole Inspection Summary

Manhole # S13O__009MH

Insp Date: **3/25/08 8:24 AM**

Location Address: **2801 Frederick AV**

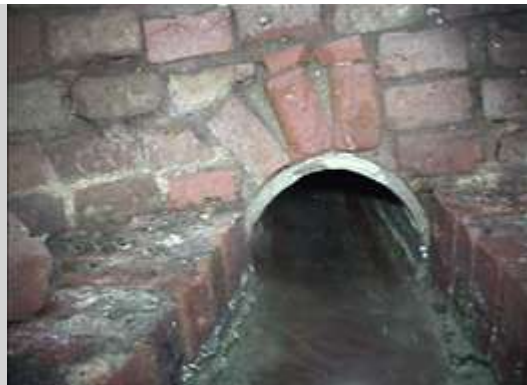
5 O'Clock Inflow

Pipe Height: **8.4** (in.) Rod and Bar (Angled)
Pipe Material: **Clay** ☐ Pipe Lined
Invert Depth: **10.36** (ft.) Flow Characteristics: **Slow**
Deposits: ☒ None ☐ Mud ☐ Sludge ☐ Debris ☐ Grease
Silt Depth: **0** (in.) Deposits Extent:
Infiltration: **None** Pipe Seal Cond: **Sound**

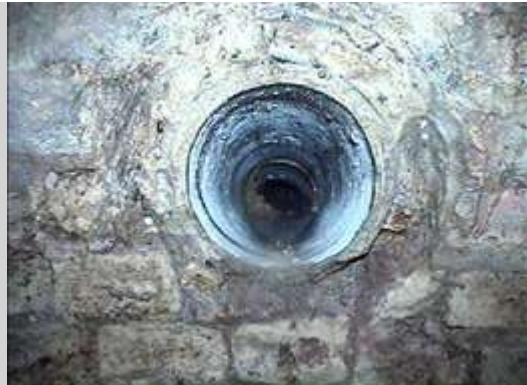
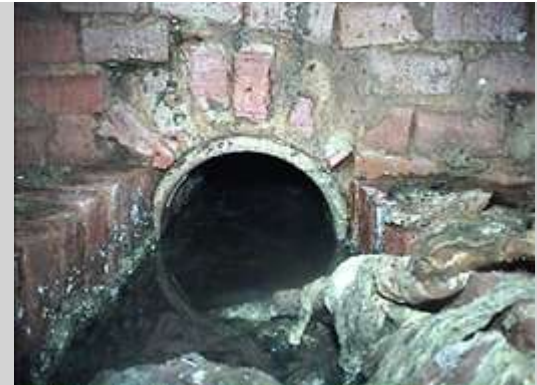
8 O'Clock Inflow

Pipe Height: **8.4** (in.) Rod and Bar (Angled)

Infiltration: **None** Pipe Seal Cond: **Sound**

Drop Condition: **Open**
